# BUILDING SURVEY REPORT

XXX Cottage  
XXX Road  
A Small Village  
Kent  
MEX XXX

Inspection: January 2024  
Report: January 2024

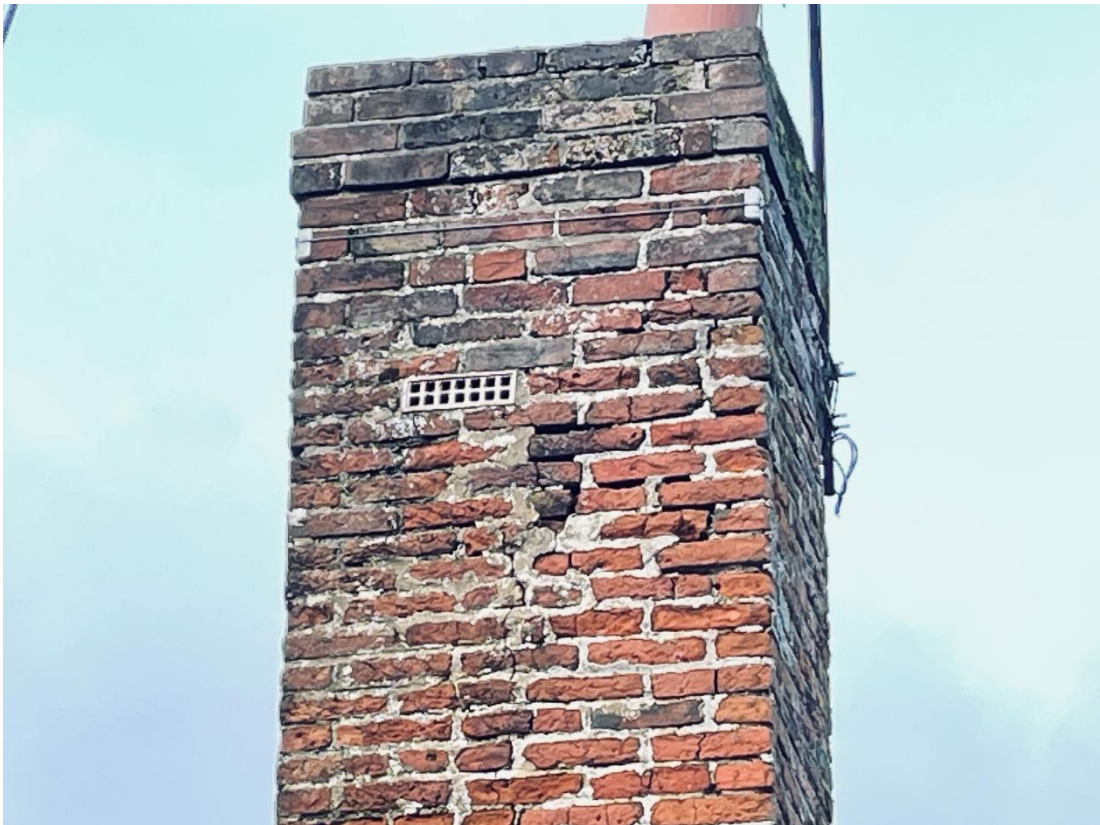
The property features a brick chimney located on the catslide roof to the front elevation incorporating a pair of flues, with one capped with a terracotta pot and the second sealed off and an airbrick installed in the right-hand facing elevation. The chimney has a significant lean towards the rear (west) and the left (south elevation) caused by the condition of the pointing. The basic rule of thumb for the plumbness of a chimney is 10mm per 1,000mm of height, and while actual measurements were taken visually, the chimney exceeds this parameter. It is therefore recommended that the chimney be reduced in height down to the height of the shoulder (subject to the brickwork being sound) and rebuilt using the original bricks set in lime-based mortar. The opportunity should be taken to incorporate a lead horizontal damp-proof course to prevent moisture from migrating down through the brickwork into the property.

Poor pointing to the chimney.

A flexible stainless-steel flue liner should also be installed to serve the wood-burning stove. If the flue has already been lined, it may be possible to reuse the existing liner.

Condition Rating: **3**

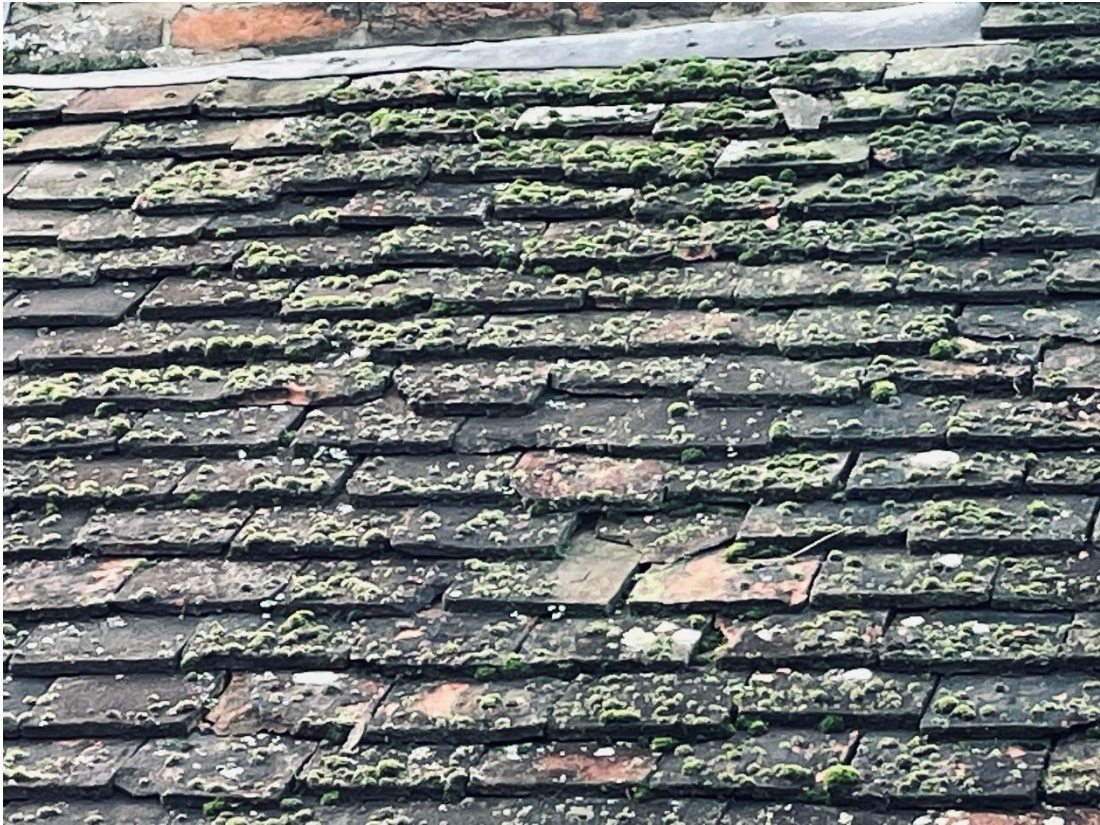
The main body of the property features a pitched roof clad with hand-made Kent peg tiles secured with timber dowels (pegs) with corresponding clay ridge tiles. The roof over the front entrance, the shower room and the rear elevation of the lounge each form a catslide roof, with the eaves being at head height. There was neither indication of significant sagging to the main roof structure nor any signs of movement or water penetration, but one broken tile was noted beneath the front elevation of the chimney which requires urgent replacement. In addition, approximately 50 frost-damaged were noted and should be replaced at the same time.

Broken tiles to the front slope of the roof.

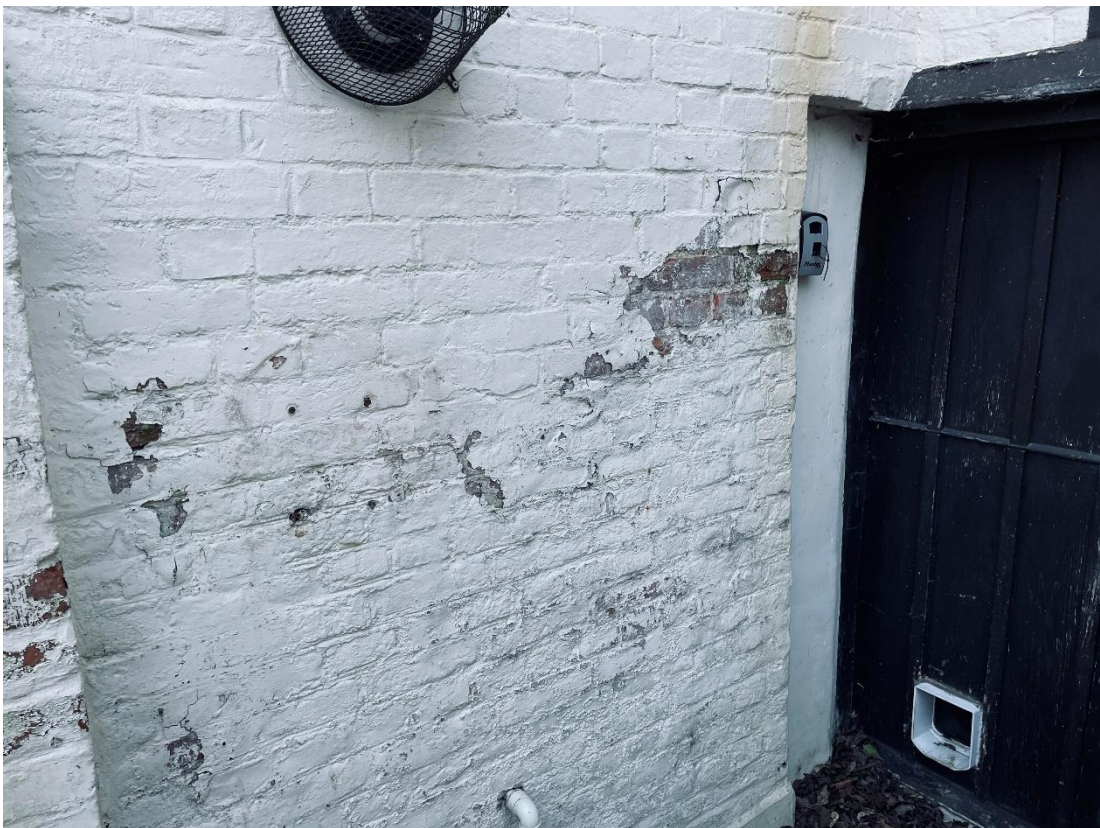
There was no evidence of cracking, and the brick courses appeared to be evenly laid with no evidence of eroded brickwork or pointing. The paintwork to the right-hand elevation of the front entrance hallway was in a poor state of repair, resulting from rainwater discharging down the wall from the guttering above. The loose paint should be scrapped back, and the wall allowed to dry for several months before being redecorated with two coats of microporous masonry paint.

Peeling paint to the right-hand elevation of the front entrance hallway.

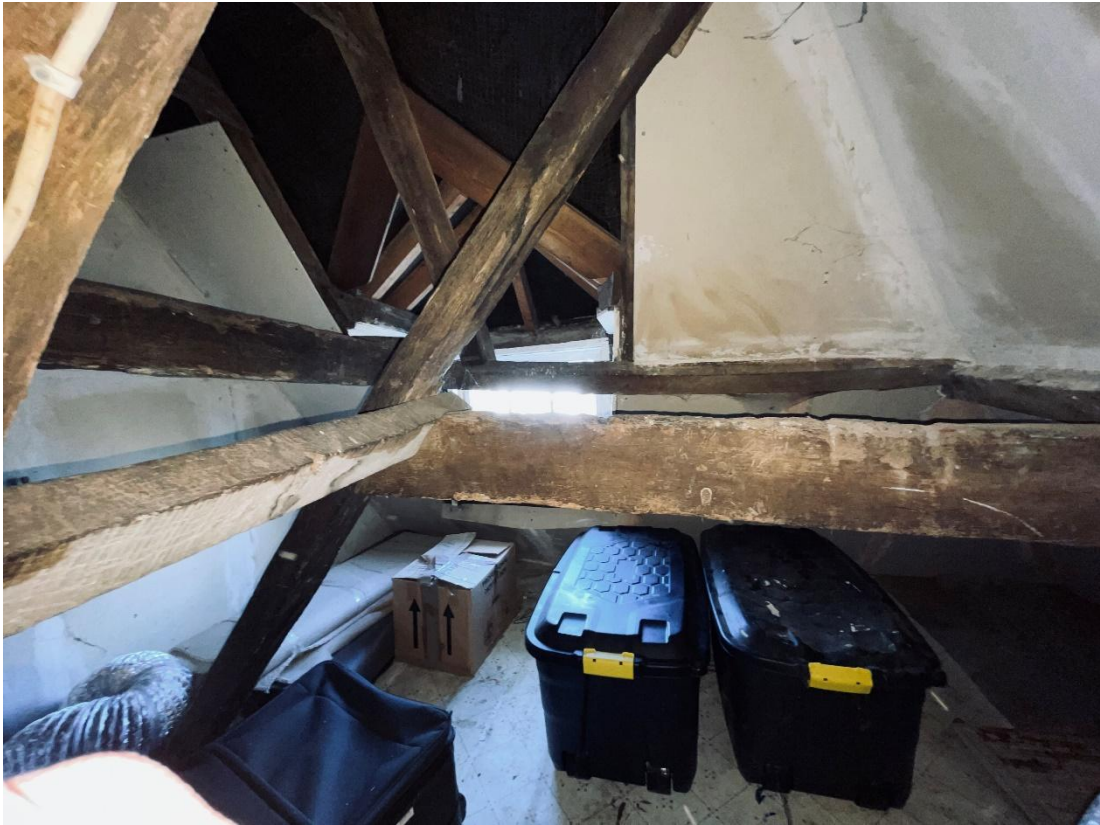
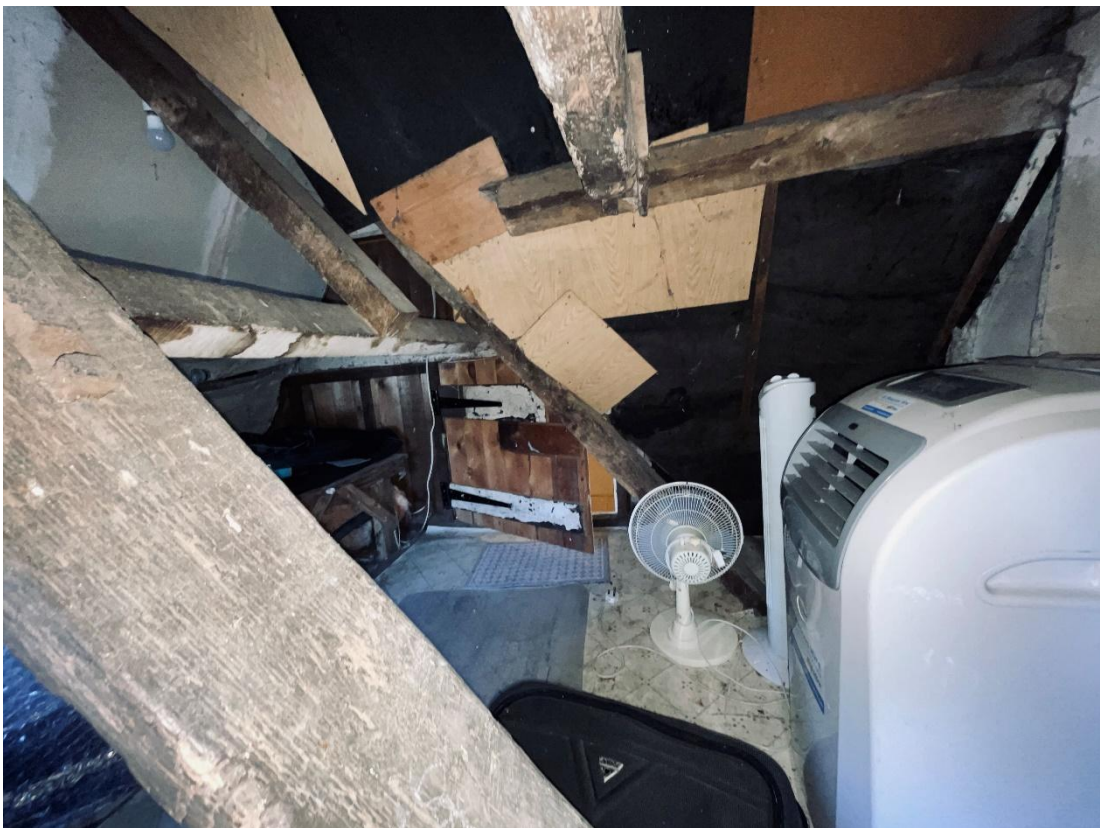
The roof space over the front entrance hallway was accessed via an uninsulated loft hatch in the hallway. There was no evidence of sagging, bowing or split timbers in the roof space, and the underside of the roof features a timber sarking underfelt, which is in good condition. Moisture readings were taken with a damp meter with no evidence of dampness recorded and no evidence of wood-boring insect infestations present.

General view of the roof space.

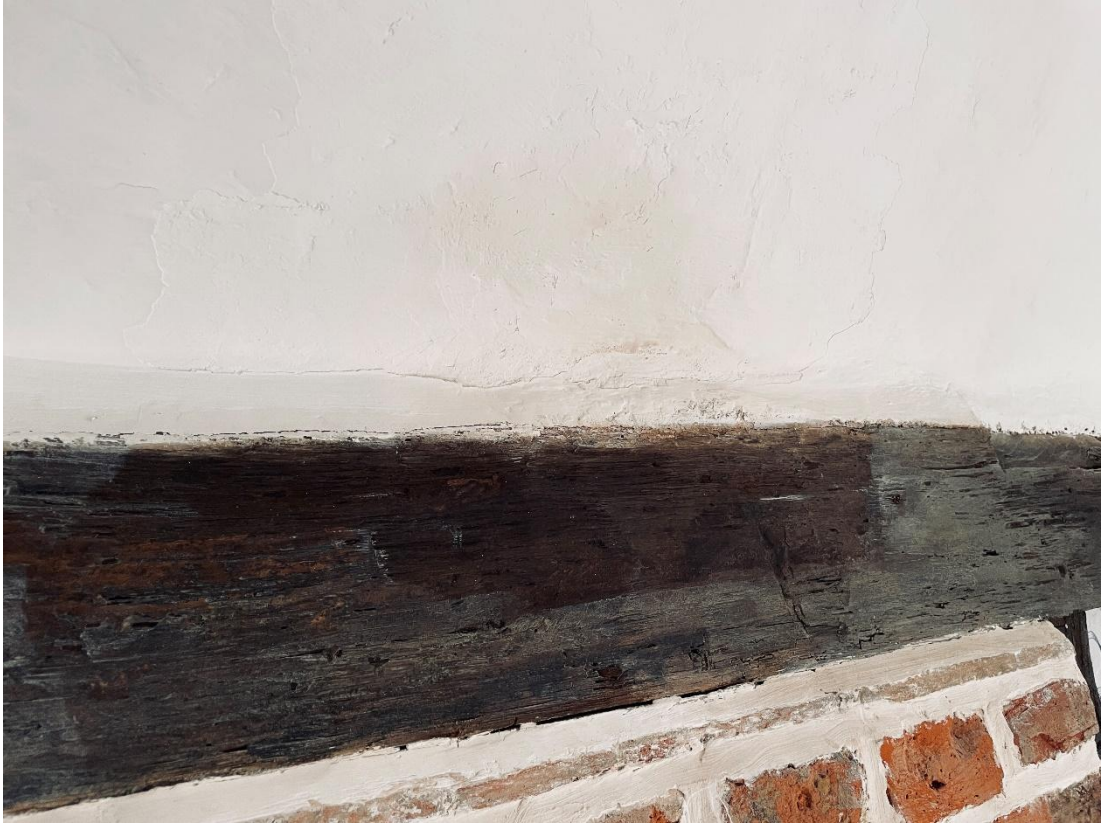
The ceilings were in good overall condition, with the majority of the rooms being free from any water staining and dampness. Water staining to the sloping section of the ceiling above the fireplace in the first-floor left-hand bedroom, which is attributed to an issue with the lead flashing weathering the junction between the roof and the chimney, as noted in Section 4.2 *Chimney*. Once the cause of the moisture has been identified and resolved, the plaster should be allowed to dry out and be decorated with an application of stainblock undercoat when undertaking the next round of internal decorations.

Dampness above the left-hand bedroom fireplace.

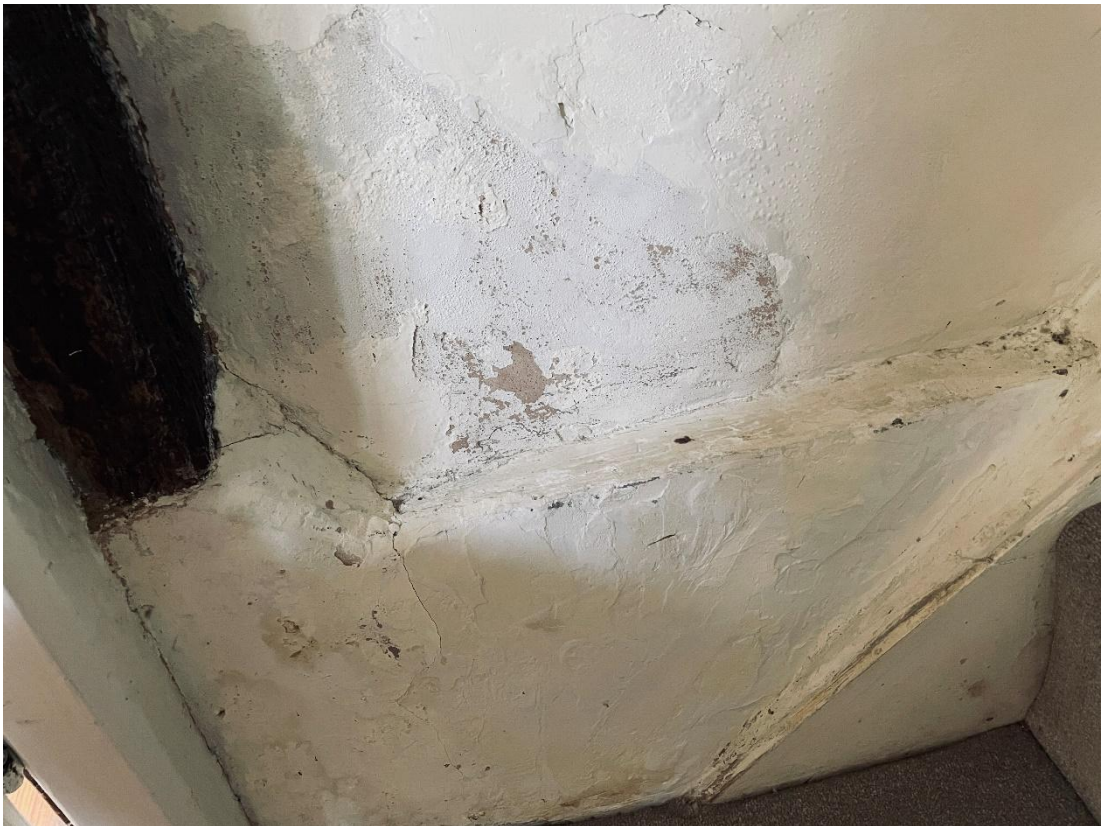
Dampness was present in the party wall at the base of the stairs leading from the main reception room, resulting in damage to the plaster and the decorations. It is recommended that the damaged areas of plaster are hacked off, the brickwork plinth left undecorated, and the plasterboard replaced with a layer of moisture-resistant plasterboard finished with a skim coat of lime-based render. The area should then be decorated with a mineral-based emulsion paint.

Dampness to the base of the stairs.

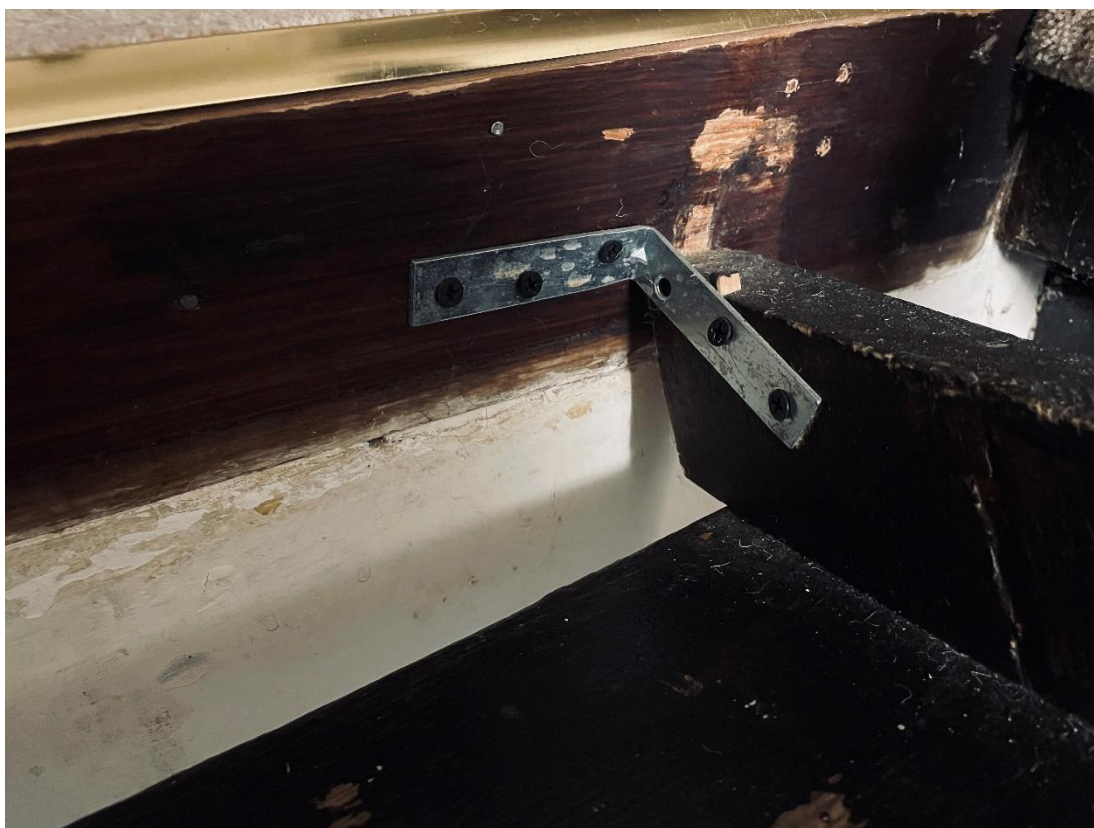
Access from the first floor to the attic rooms was via a ship's ladder, which was inadequately fixed at the top with a pair of metal brackets secured with screws. A timber batten should be placed on the face of the second-floor structure to support the underside of the head of the ladder.

Inadequately supported ship's ladder.

Condition Rating: **3**

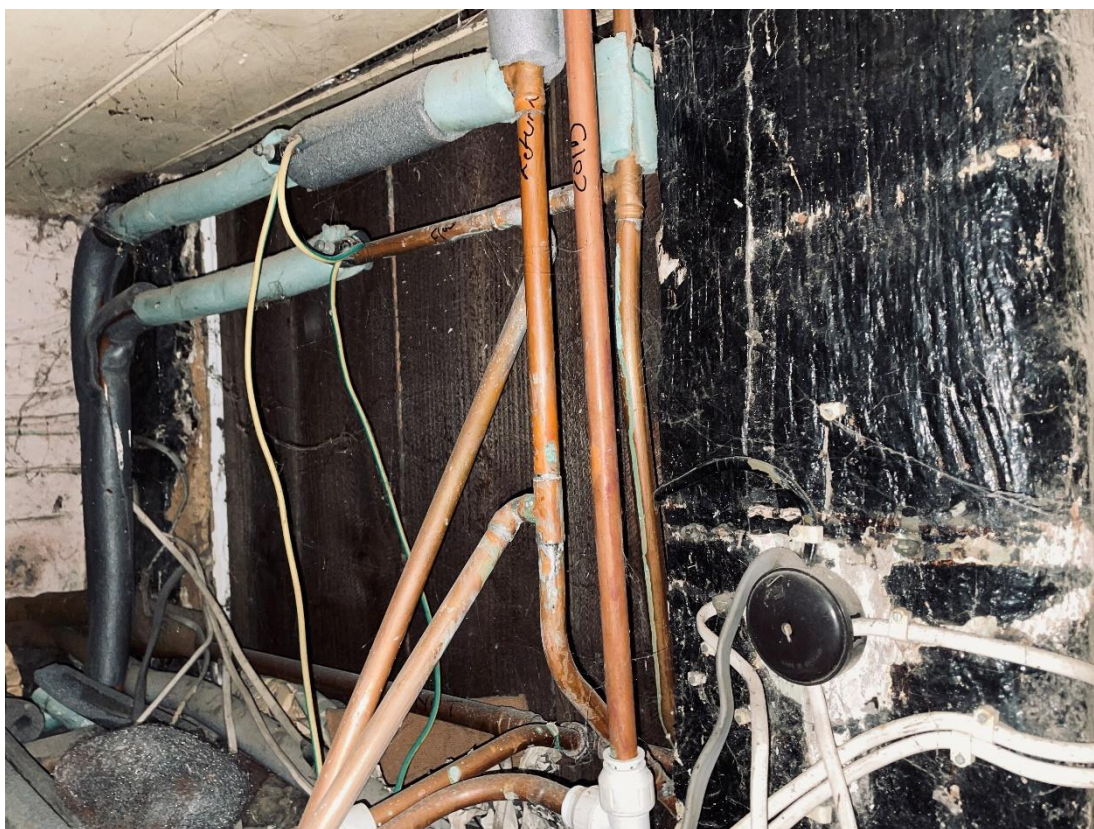
Uninsulated pipework in the loft over the entrance hallway.

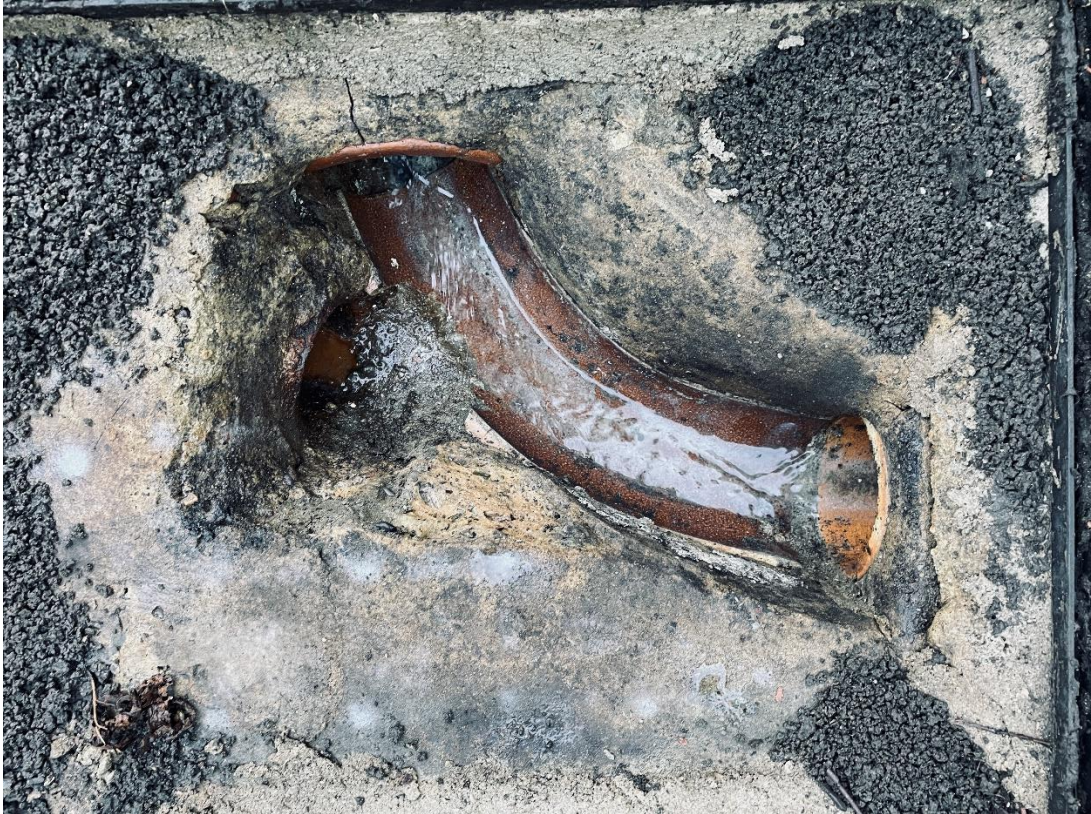
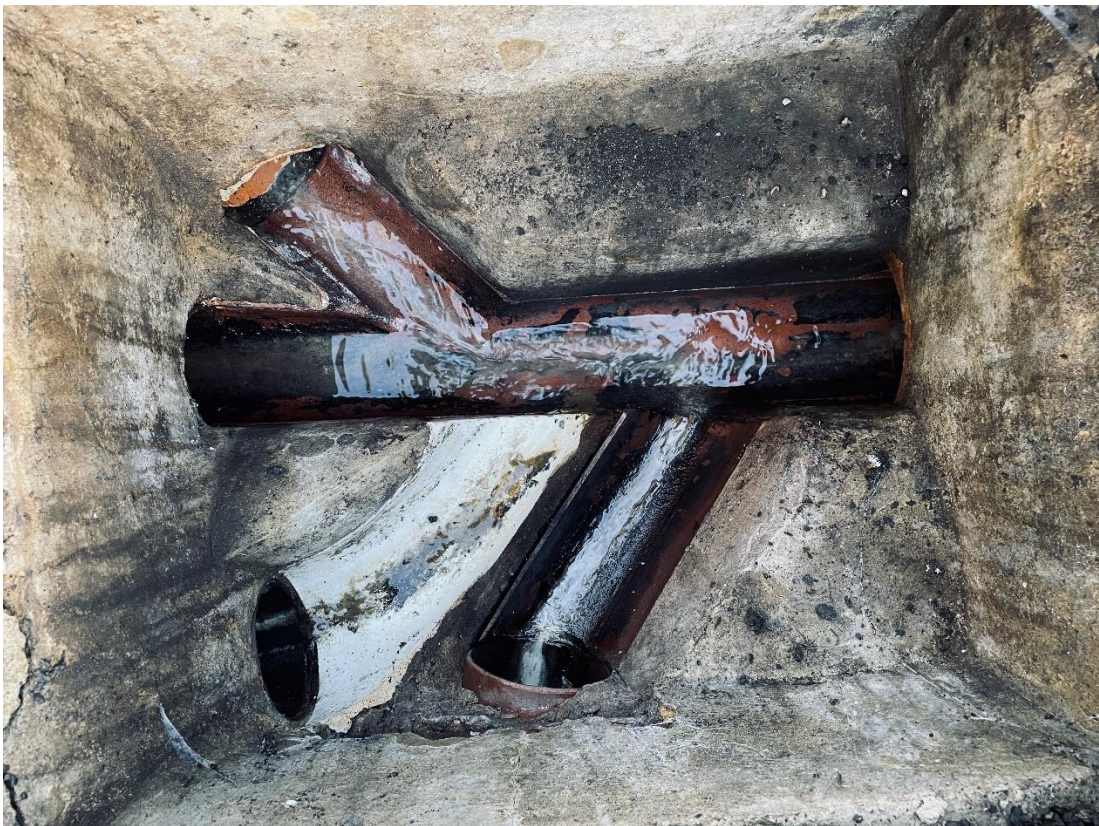
There was no above-ground sign of blockages or any other significant defects at the time of the inspection. The garden contains a pair of cast-iron inspection covers, which were lifted, and the drains were found to be free of obstructions, with no standing water or evidence of any recent tide marks, and the chambers and benching were in good overall condition.

General view of the below-ground drainage system.

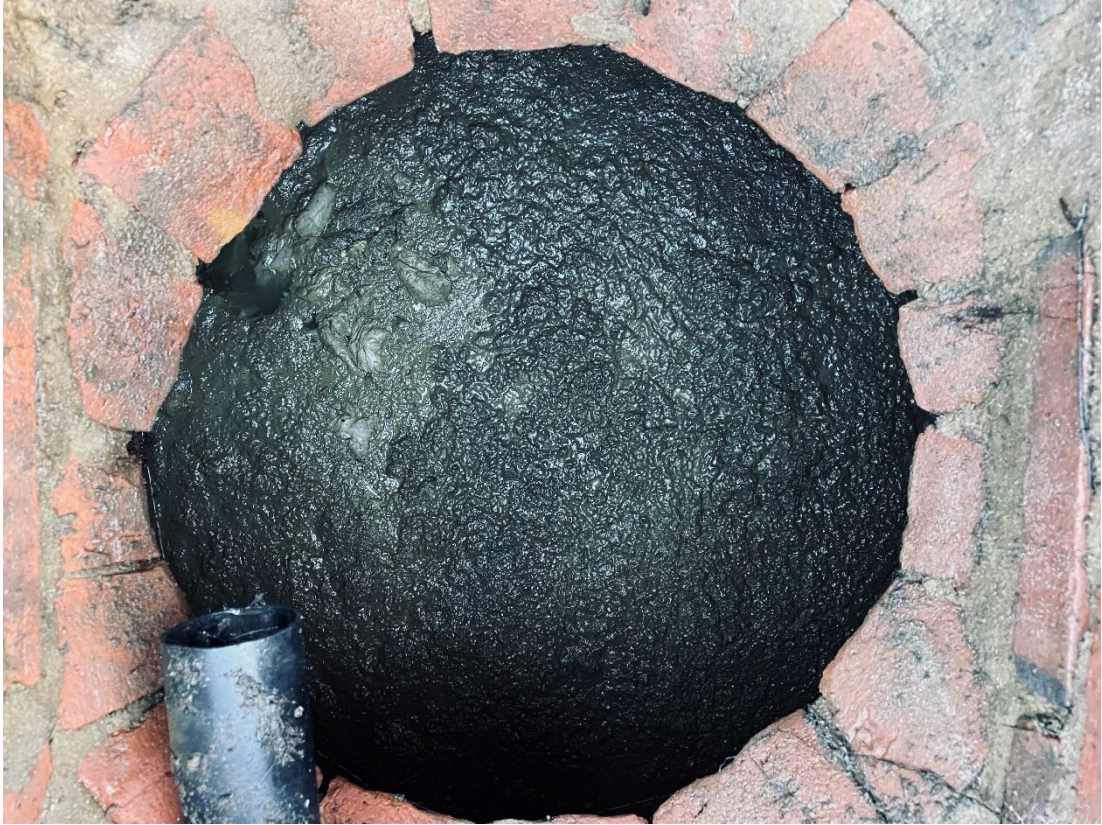
Disused soakaway.
